EPA-600/7-80-004
January 1980

Spill Prevention, Control and Countermeasure Practices at Small Petroleum Facilities

Nicholas P. Trentacoste
George R. Bierman
James Cunningham
Science Applications, Inc.
McLean, Virginia 22102

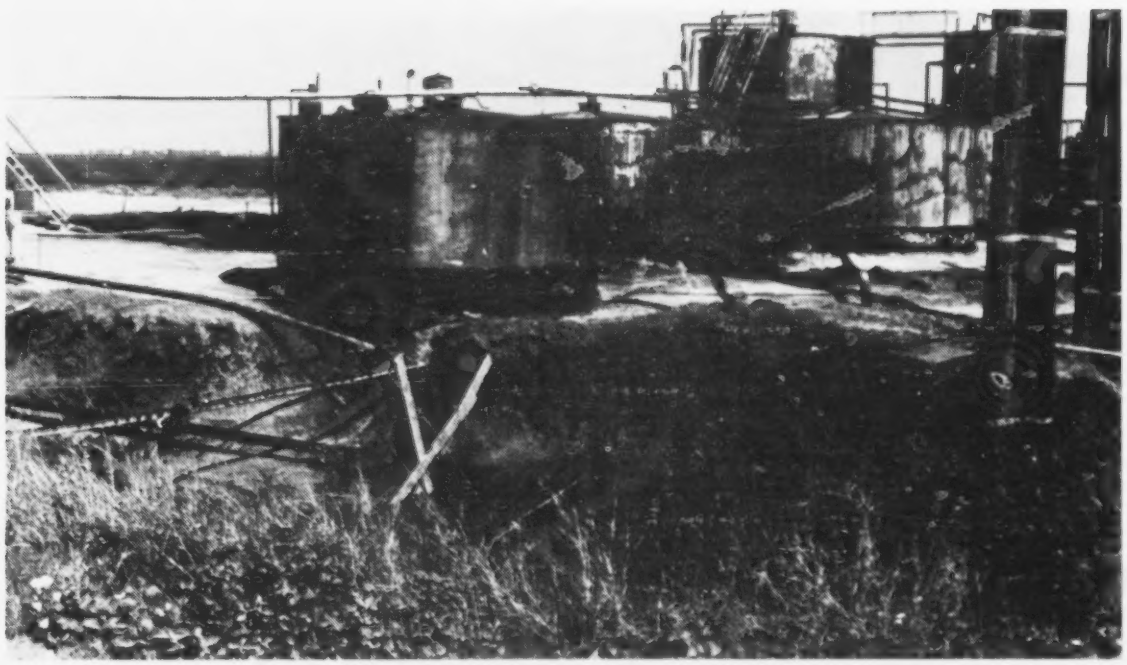
Figure 8 (a & b). Variations of the basic stripper well facility — Texas/Oklahoma area.

3) Improper discharge, clean-up and disposal of BS&W, rainwater and tank overflows were noticed at the sites and existing SPCC plans failed to properly address this problem by specifying needed procedures and equipment (see Figures 8a and b).

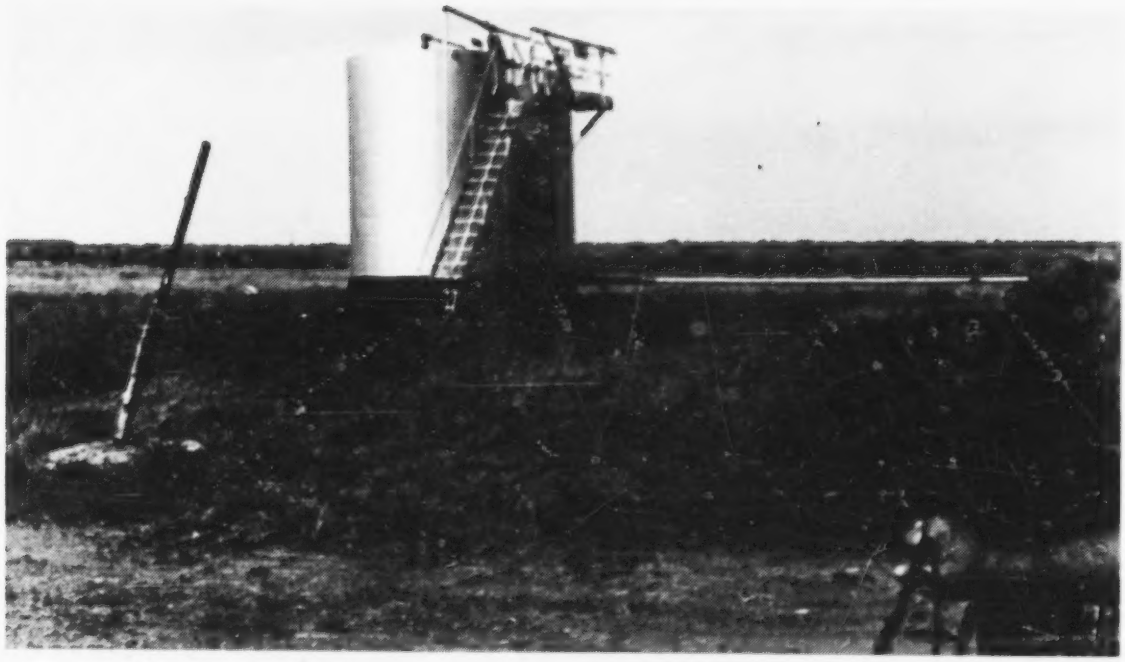
Figure 8 (i & j). Inadequate security fencing (i) and no security fencing (j) surrounding typical stripper well facilities - Texas/Oklahoma area.

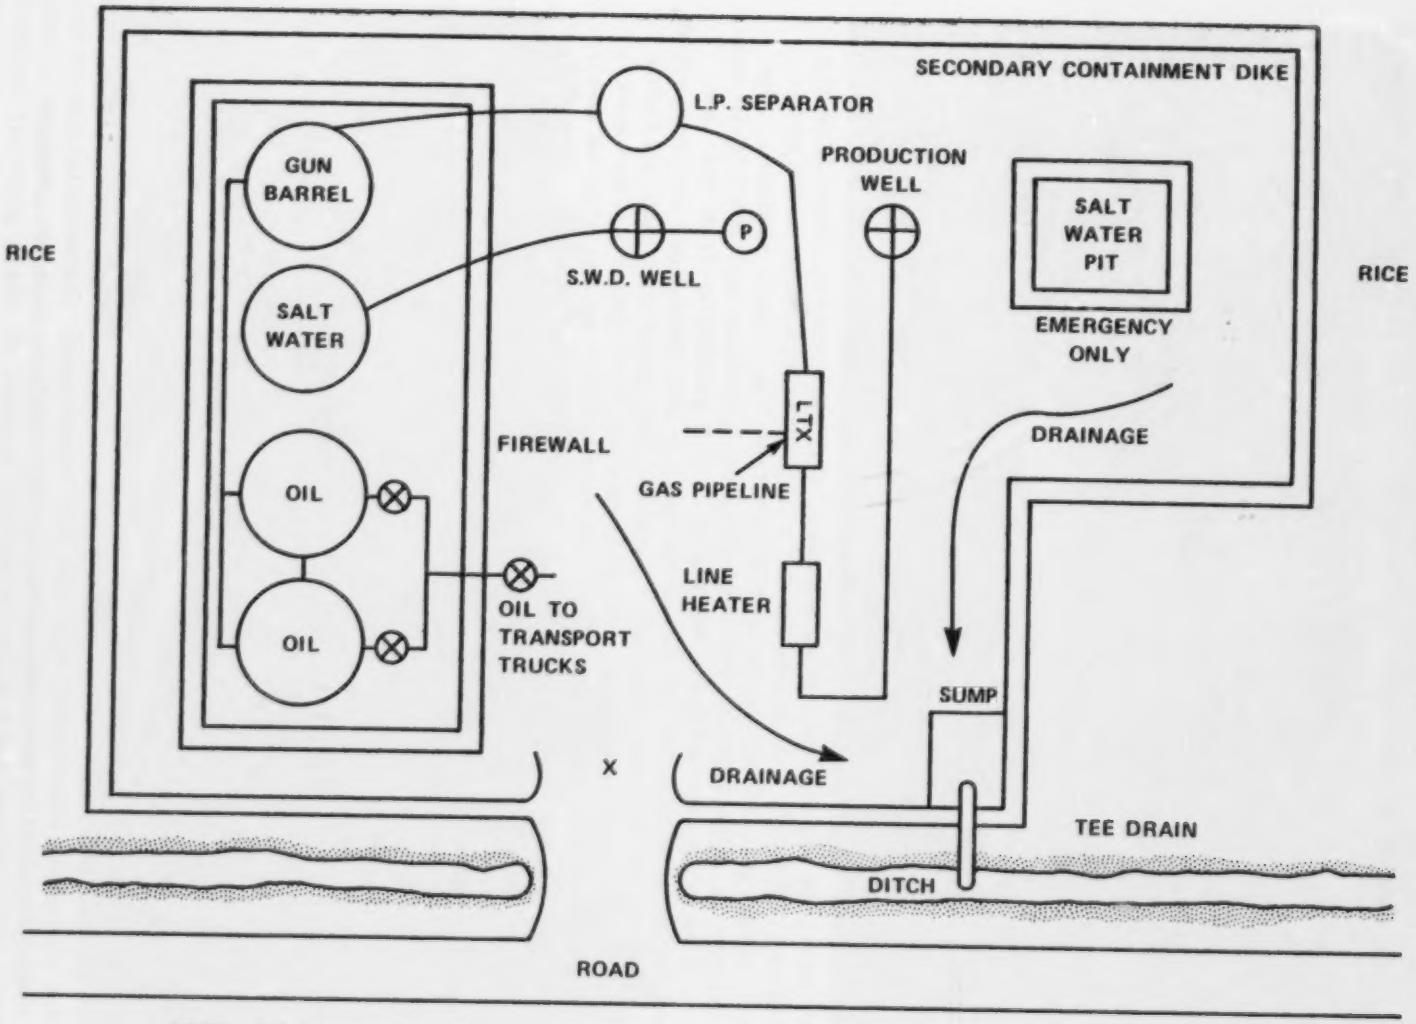
NOTE: This entrance area (X) tends to be too low.

Figure 17. Typical on-shore facility.

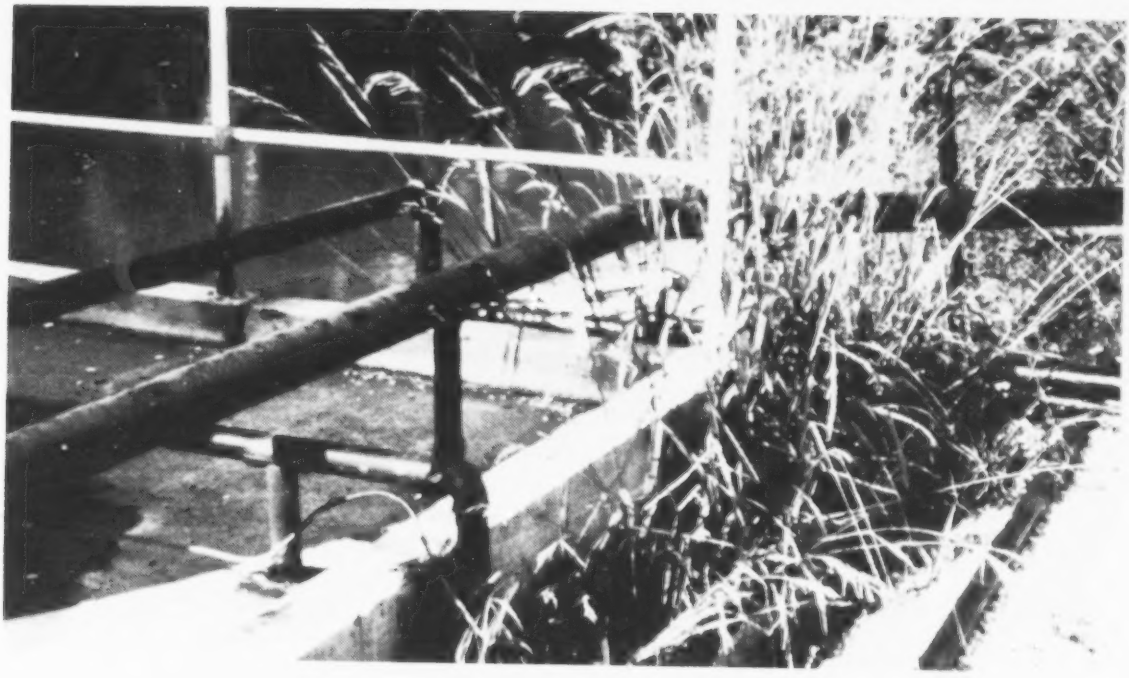
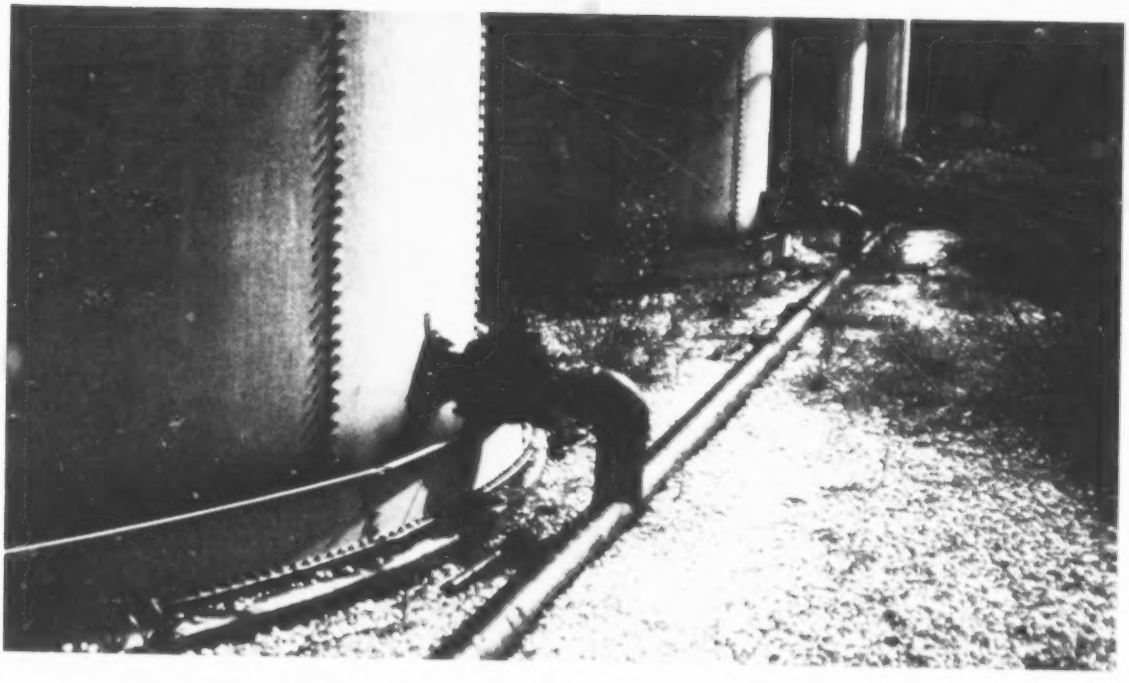
Figure 23 (a & b). Typical minimal leak protection at platform-mounted water-based facility.

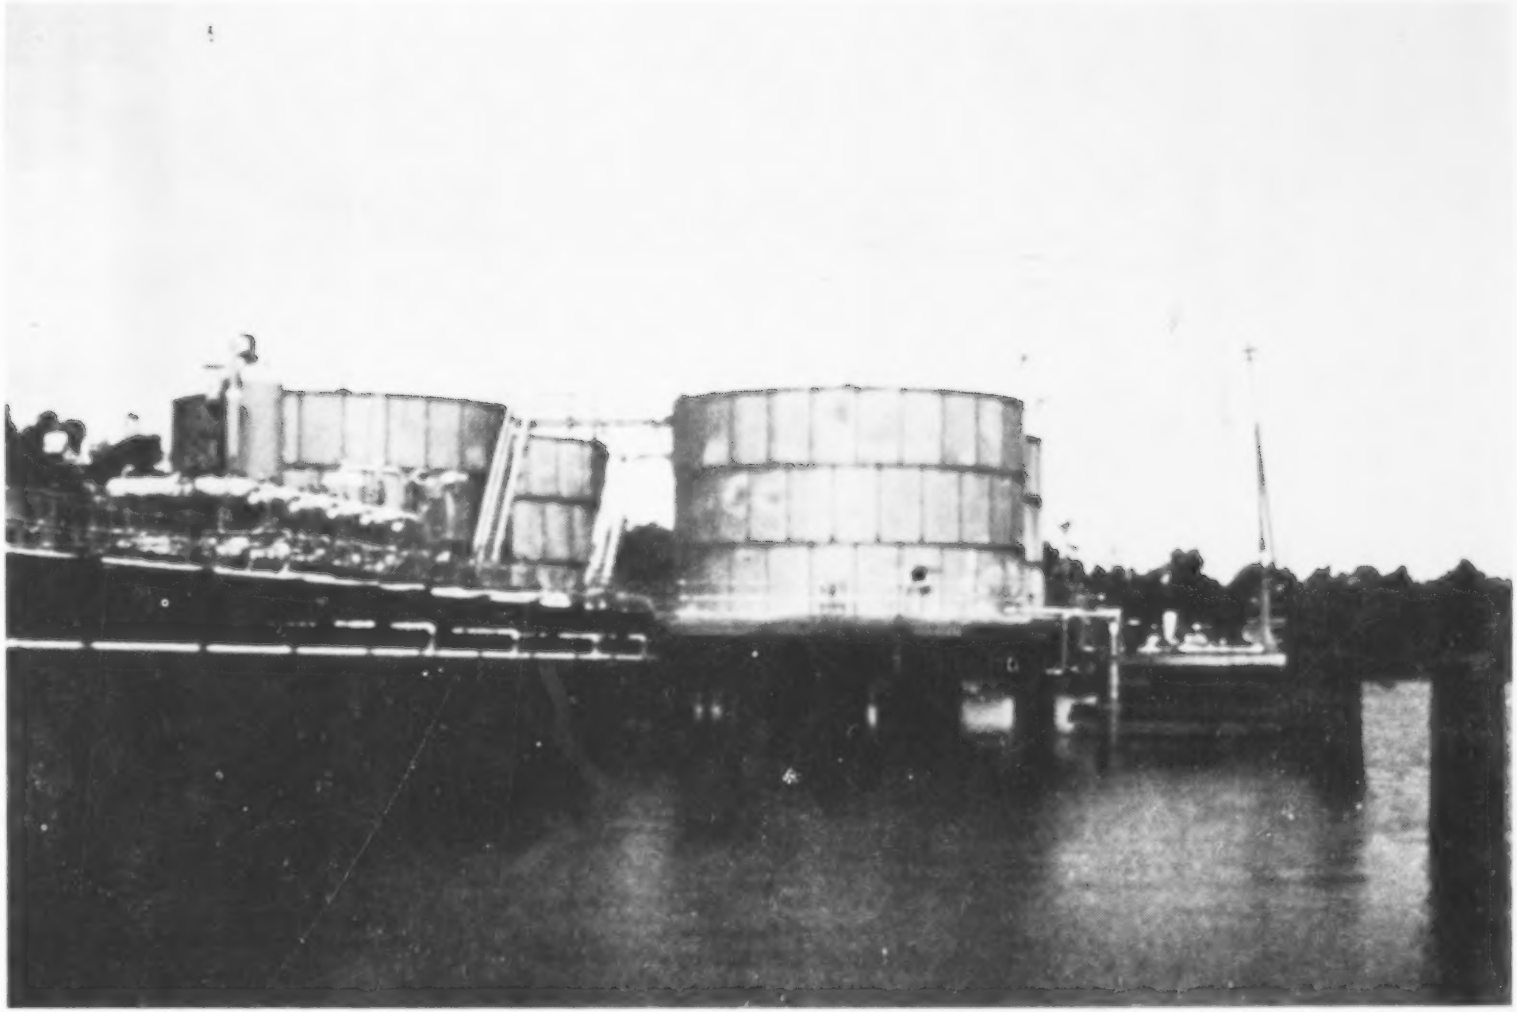
Figure 24. Typical unprotected over-water piping at water-based facilities.

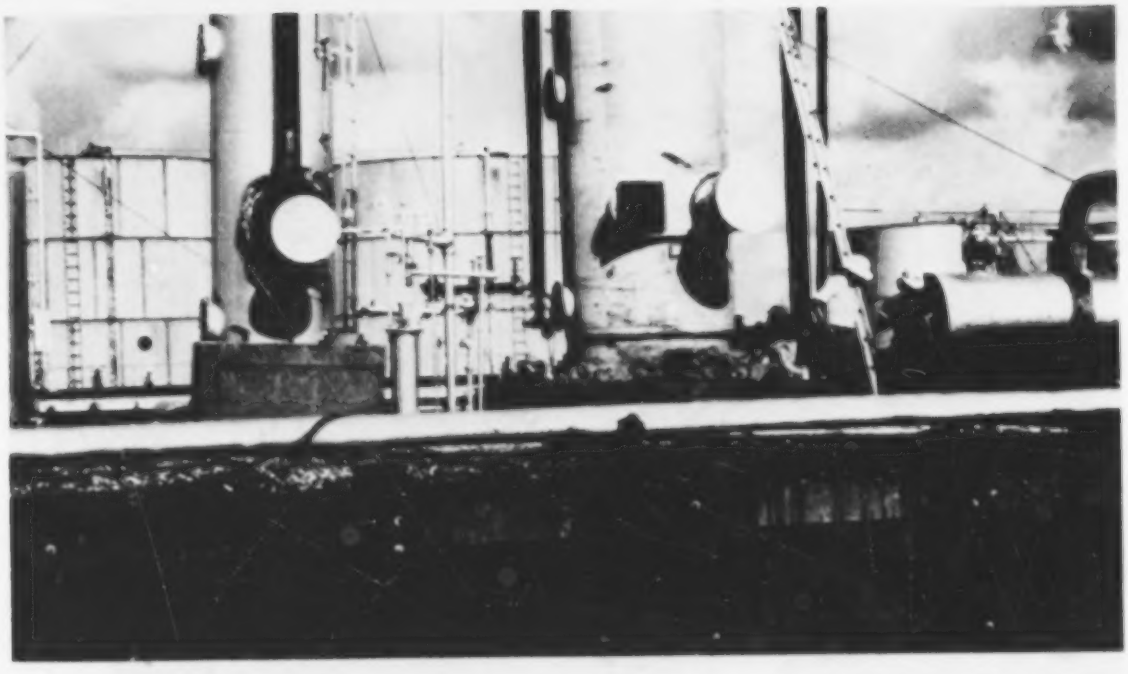
Figure 25 (a & b). Water-traffic-induced bank erosion at a water-based facility (a) and typical bulkheads used to correct the erosion problem (b).

- To prevent soil/dike erosion caused by excessive waterway traffic, bulkheads should be designed for shore-based facilities

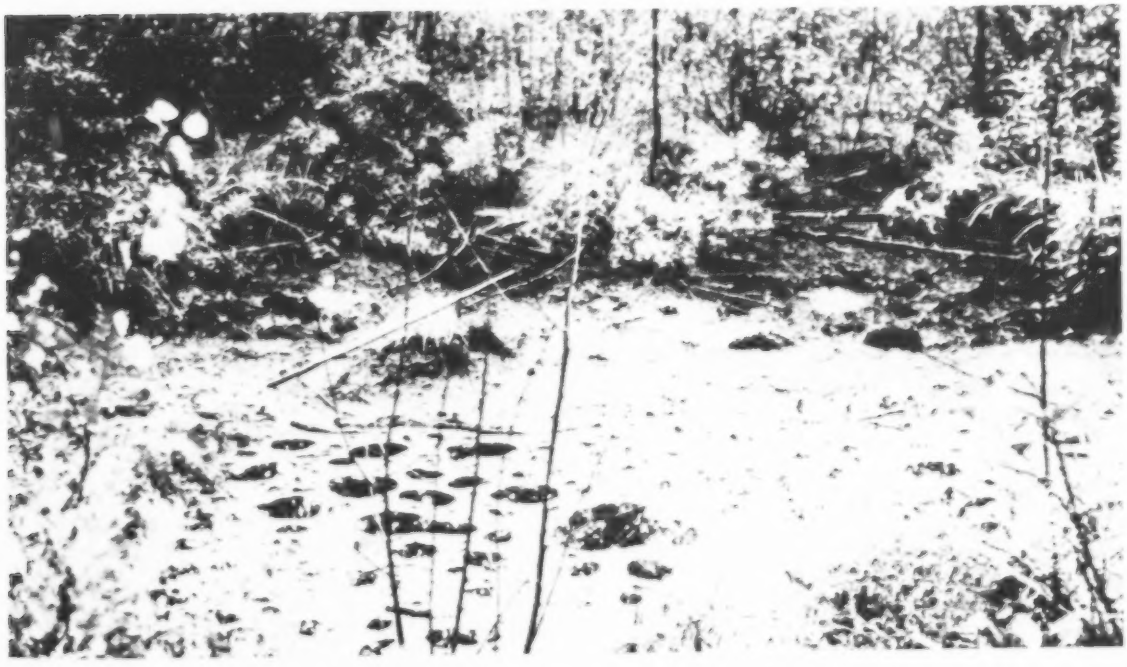
Figure 33 (d). Details (disposal pit) of a 60-well stripper facility in Pennsylvania.

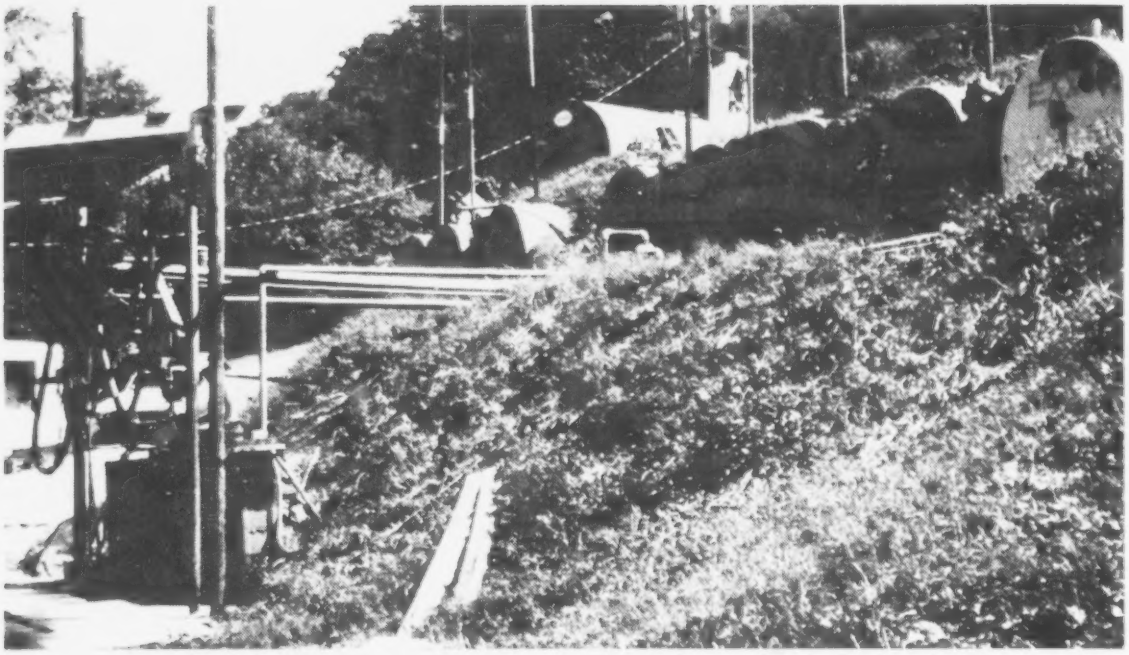
Figure 37 presents views of a 41,000-gallon-capacity bulk distributor located on the terrace of a steep hillside. Figure 37 (a) shows the terrain and underground tanks which are filled from the top levels. A highway is located about 50 feet to the right of the facility, followed by steep hillsides. At the extreme left center of the picture is a railroad which parallels the highway. All of the drainage from this facility is toward the railroad, at which point the owner has plans for the construction of a retention wall. Figure 37 (b) shows the loading rack at the facility.

Figure 37 (a & b). A 41,000-gallon bulk plant on a steep hillside location-Penn-Grade area.

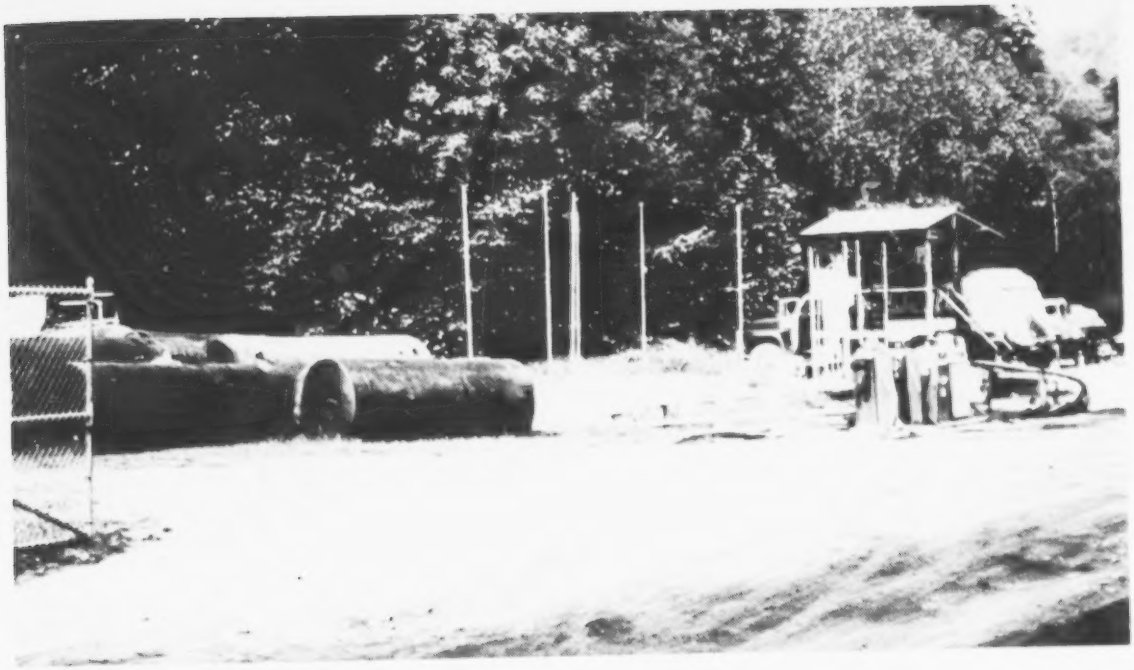
Figure 38 (a & b). A 56,000-gallon bulk station in a valley between two hills — Penn-Grade area (note earthen containment dikes at rear of both photographs).

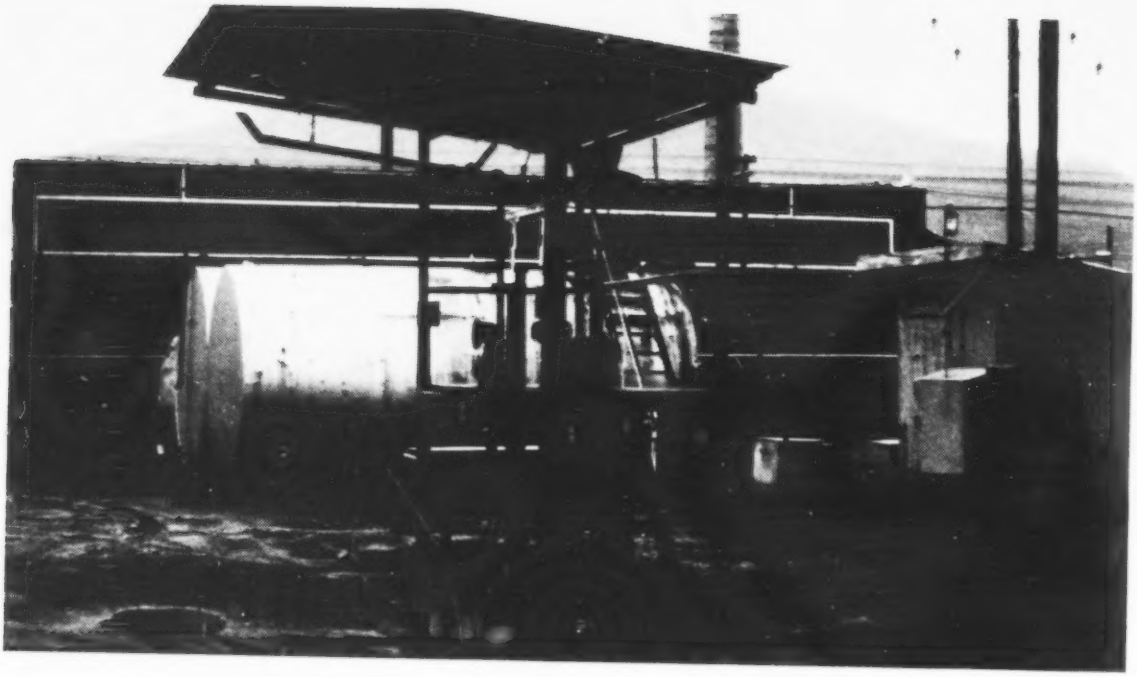
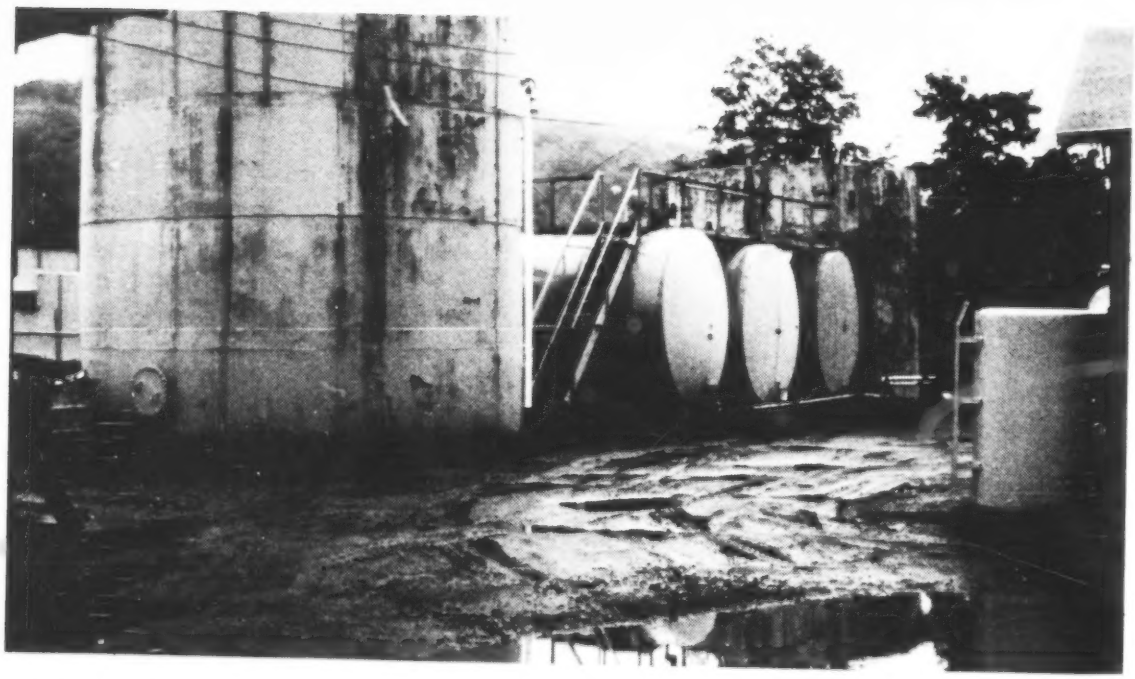
Figure 39 (a & b). Bulk plant in a congested city area — Penn-Grade area. This facility does not have any containment dikes around its tankage.

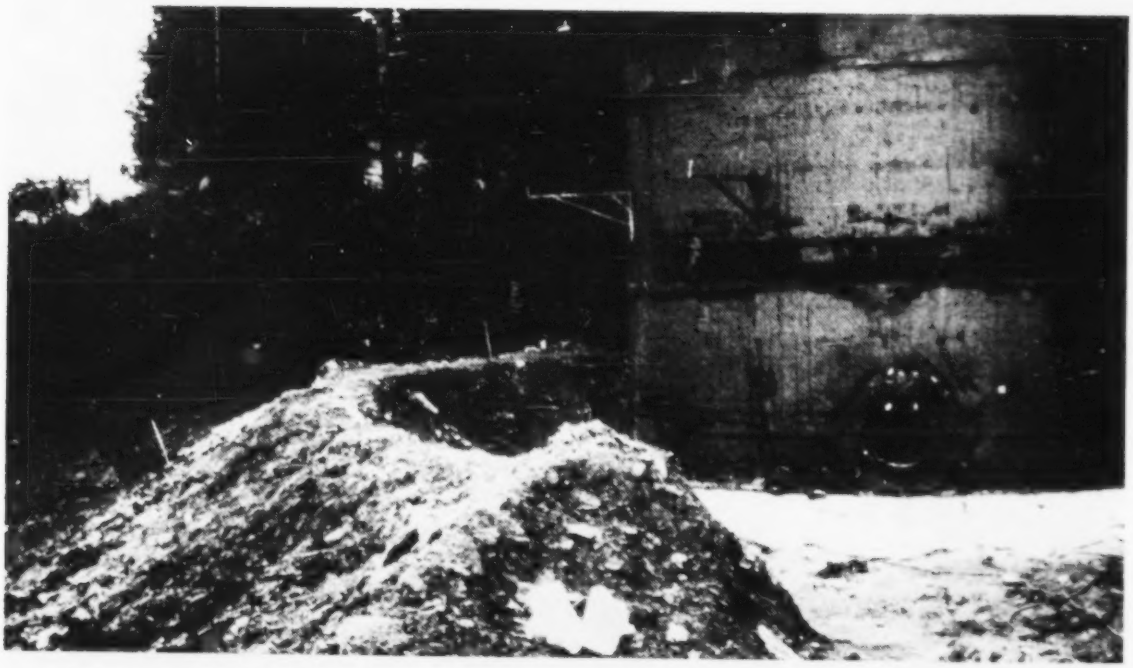
Figure 40 (a & b). A 149,000-gallon bulk plant located on a bluff — Penn-Grade area. Dike construction shown around a new tank installation.

4) For hillside locations, containment can be provided in most cases by dikes, earth or masonry, and natural barriers. One weakness noted in containment was at driveways where dikes are interrupted. A solution to this problem would be to continue the dike and provide ramps as required for truck access.

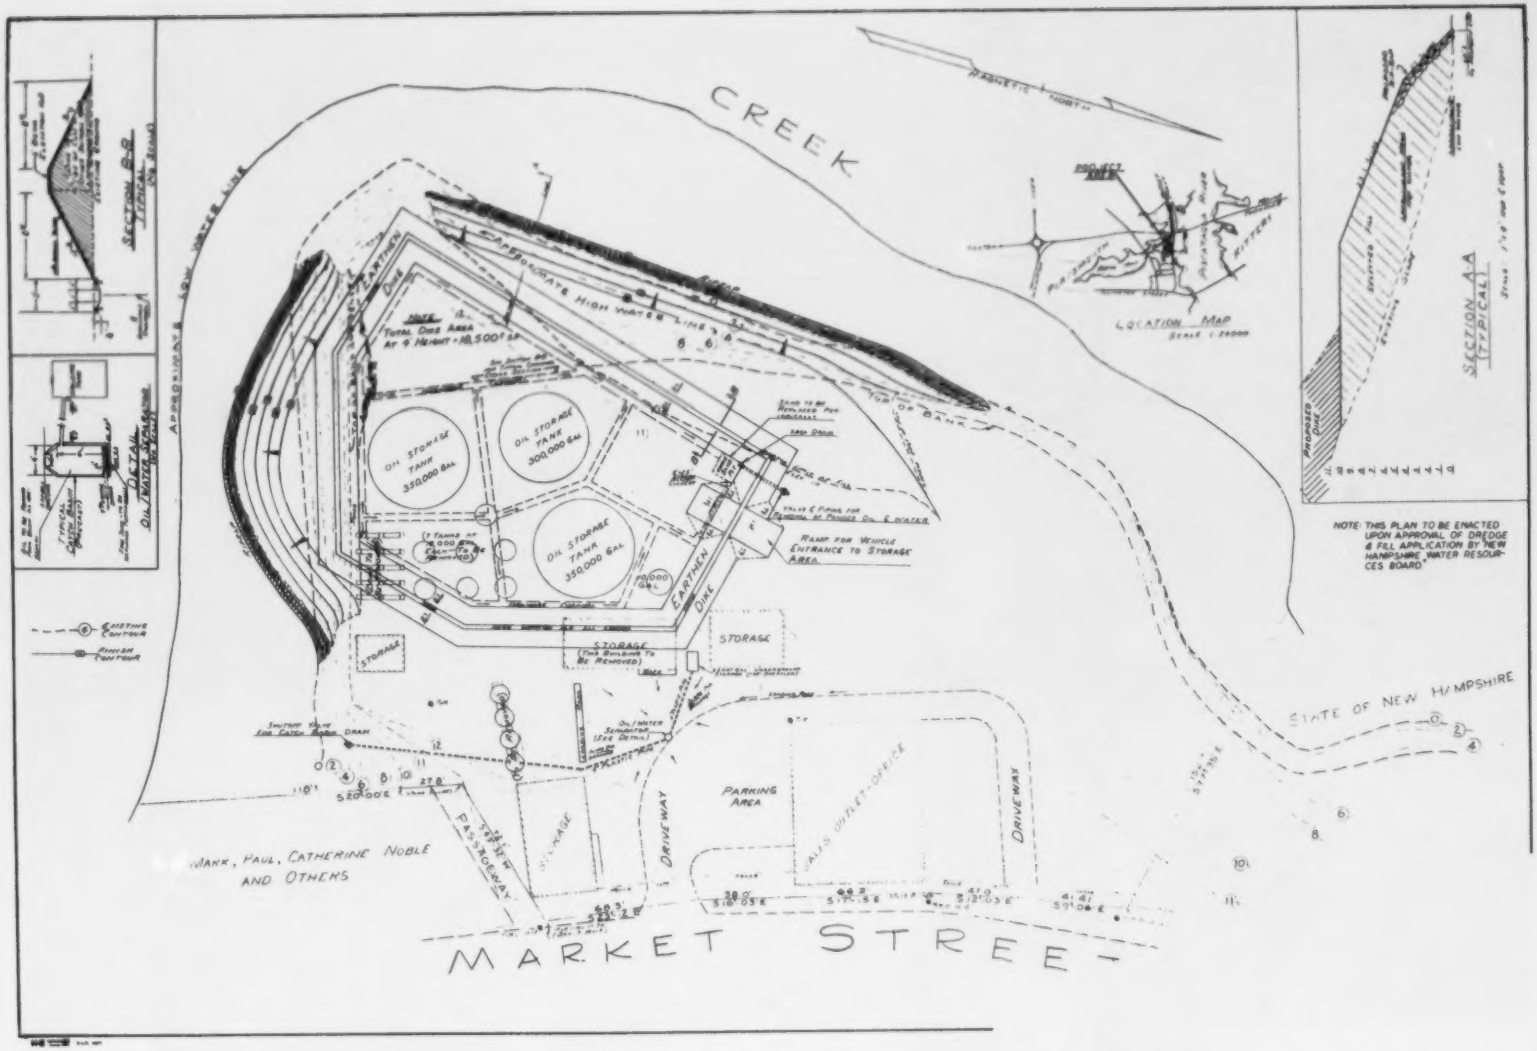
Figure 46. SPCC plan layout for a large independent bulk plant in New Hampshire.

This facility was not in business at the time of the survey, as far as storage was concerned, and was for sale. However, a good SPCC plan costing $2,000 had been prepared for this installation and the design changes are represented in Figure 46. The total estimated cost of implementing this plan was approximately $20,000.

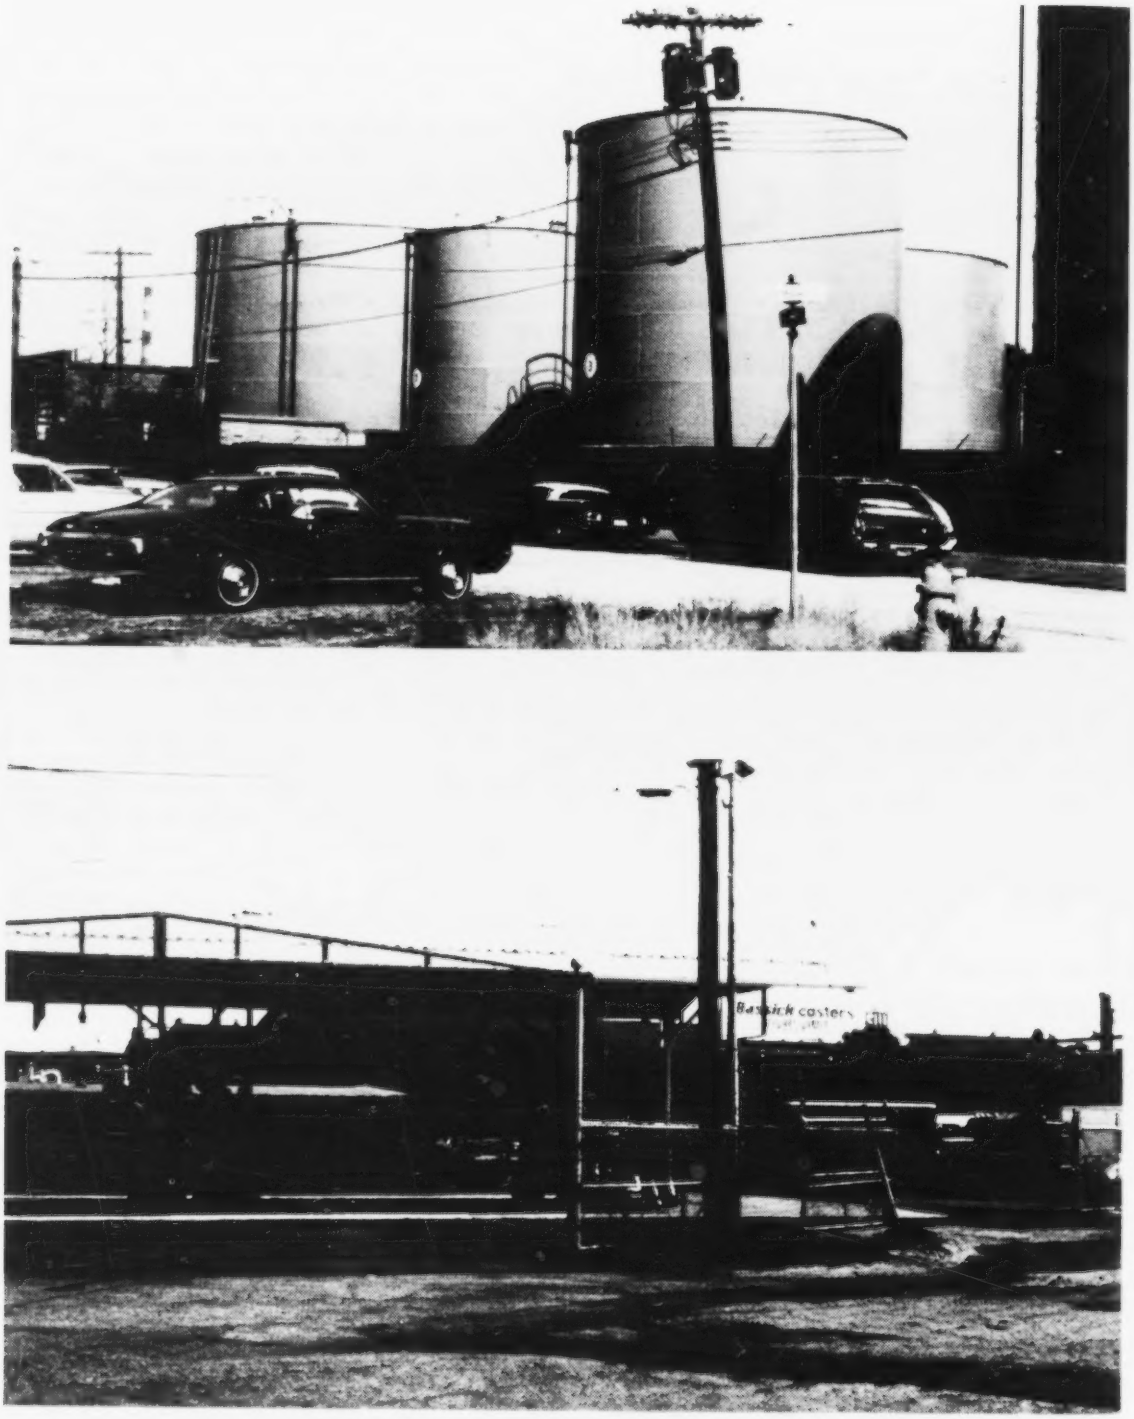
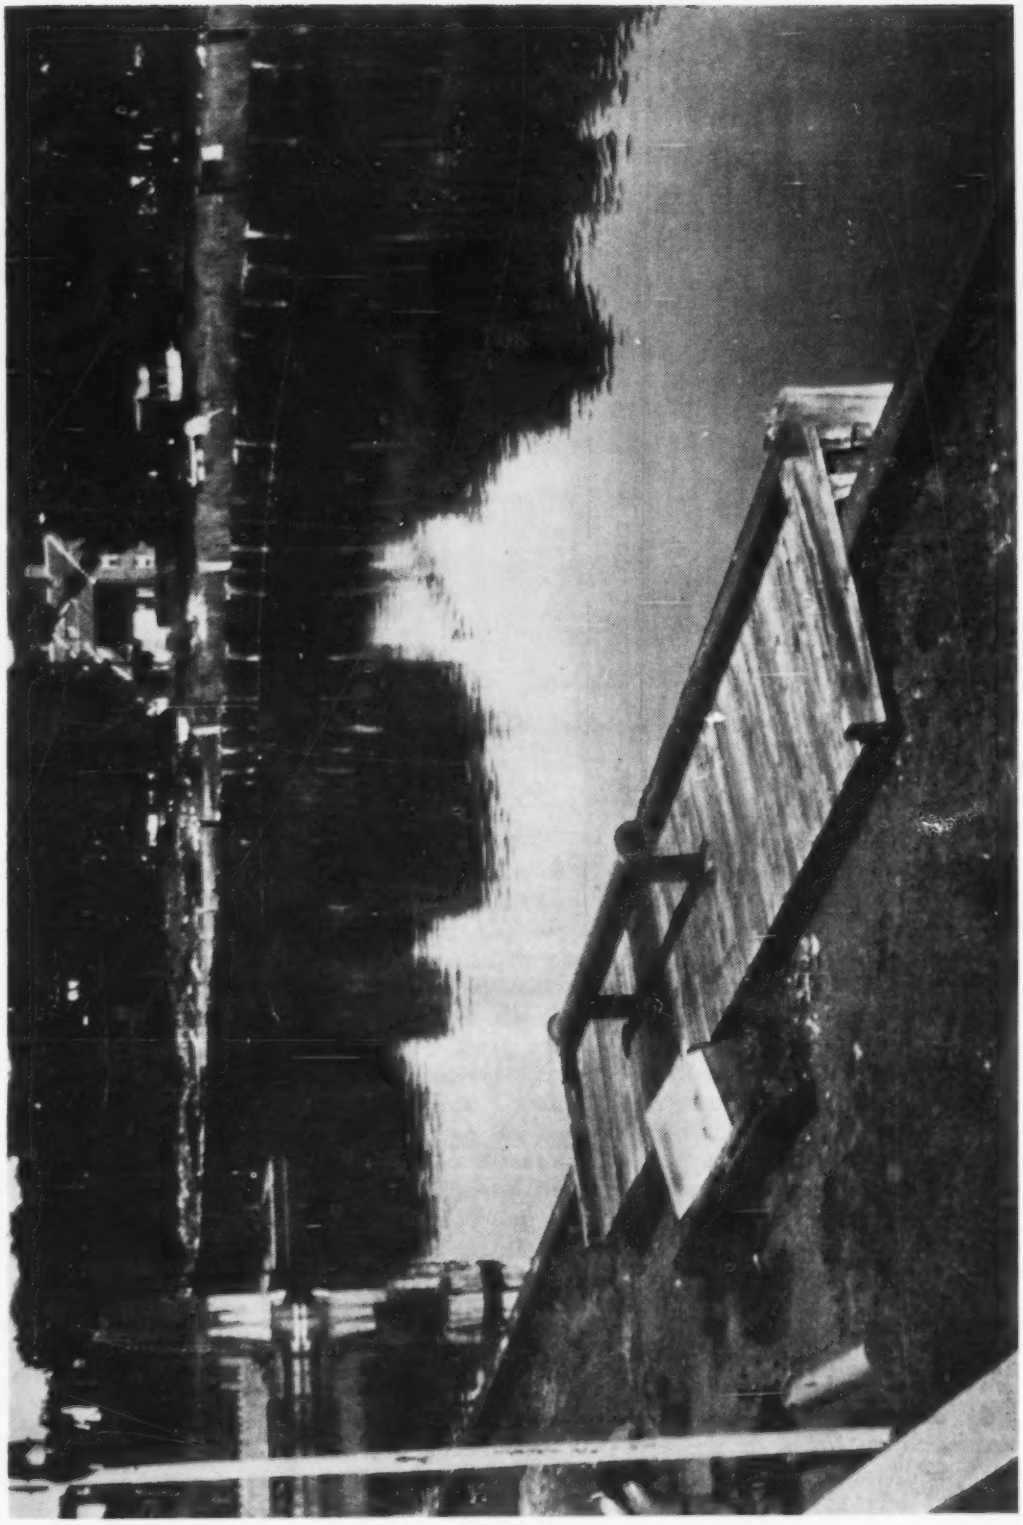
Figure 47 (a & b). Large bulk plant in Connecticut.

Large Fuel Oil Distributor (Connecticut) — This facility is located in Bridgeport Harbor on a short canal leading out from Long Island Sound. The site is illustrated by Figure 47. The storage capacity for this facility is 2,000,000 gallons of fuel oil. A drawing of its SPCC plan is shown by Figure 48. In complying with OSHA, NFPA, USCG, and EPA regulations, the facility owner stated that he was spending in excess of $140,000 to improve the installation. Up to the time of the survey, the following improvements had been made at this facility: Sandblasted and reworked all storage tanks, repaired or replaced all pipes and manifolds and color coded them, installed a foam system in case of fires, provided a boom around barges, installed high-level alarms, and provided sumps and curbs around truck-loading facilities. All of this work resulted in a considerable loss of sales because of the long shutdown times required to complete the work.

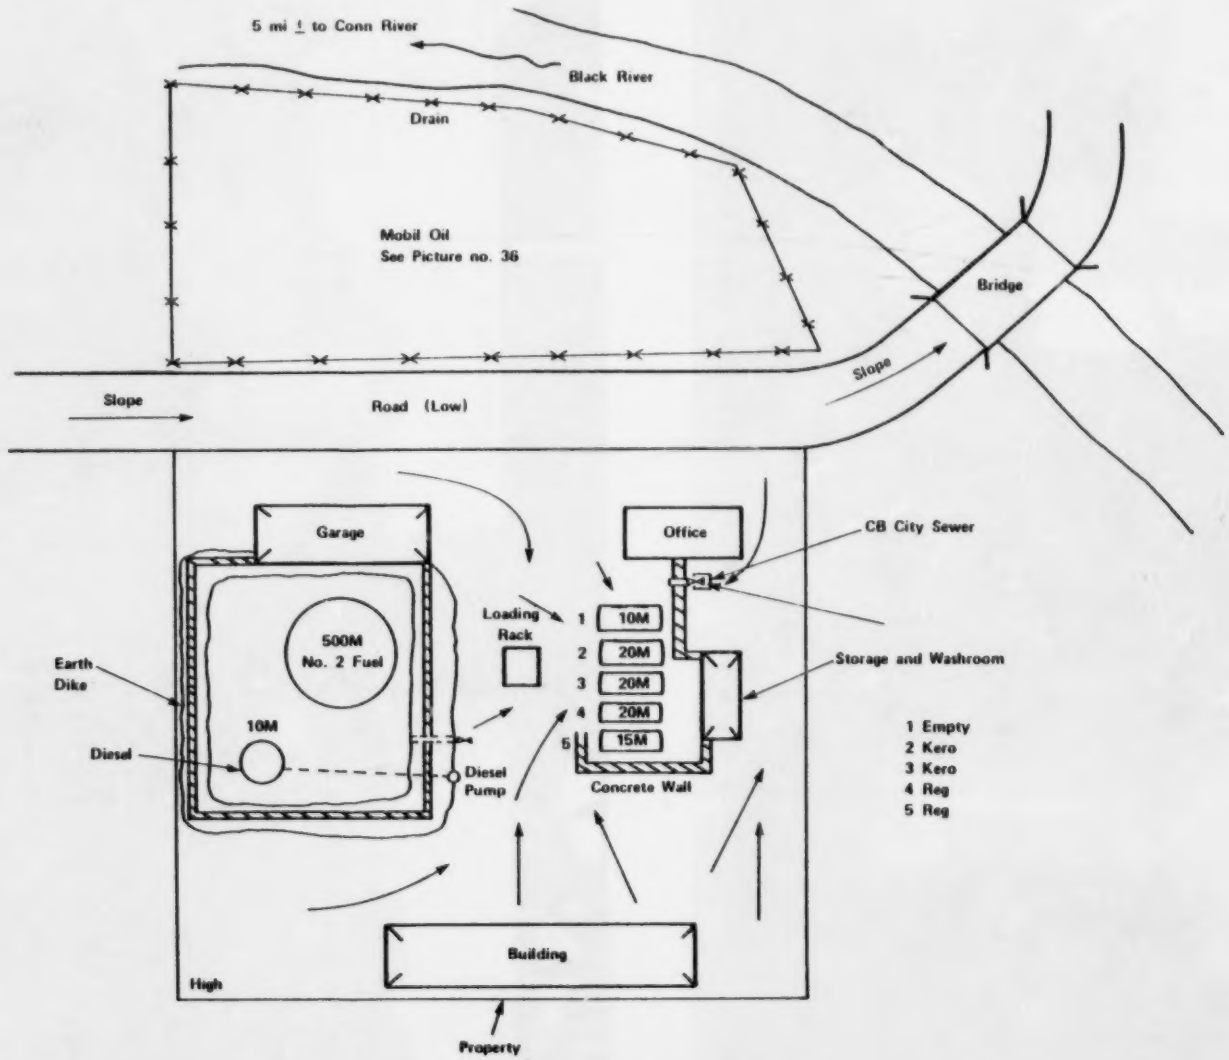
Figure 51. Layout of small bulk plant No. 2 in Vermont.

Small Fuel Oil Distributor (Vermont) — The facility shown in Figures 51 and 52 is in fairly good condition with the one exception of security fencing. The general drainage pattern for this facility (see Figure 51) is directed toward the catch basin for a city storm sewer. During heavy rains, water accumulates in the vicinity of the horizontal storage tank battery and must be drained from this area. Even a minor spill during this time could create some potential problems.

A concrete block wall begins behind the office building (Figure 51) and encloses three sides of the horizontal tanks. The area under the tank battery averages 10 inches below the grade level outside of the tank area where the city storm sewer catch basin is located. A full tank rupture would probably flood toward the loading rack and street. In order to prevent this from

happening, the concrete block wall should be extended so as to enclose the entire tank battery.

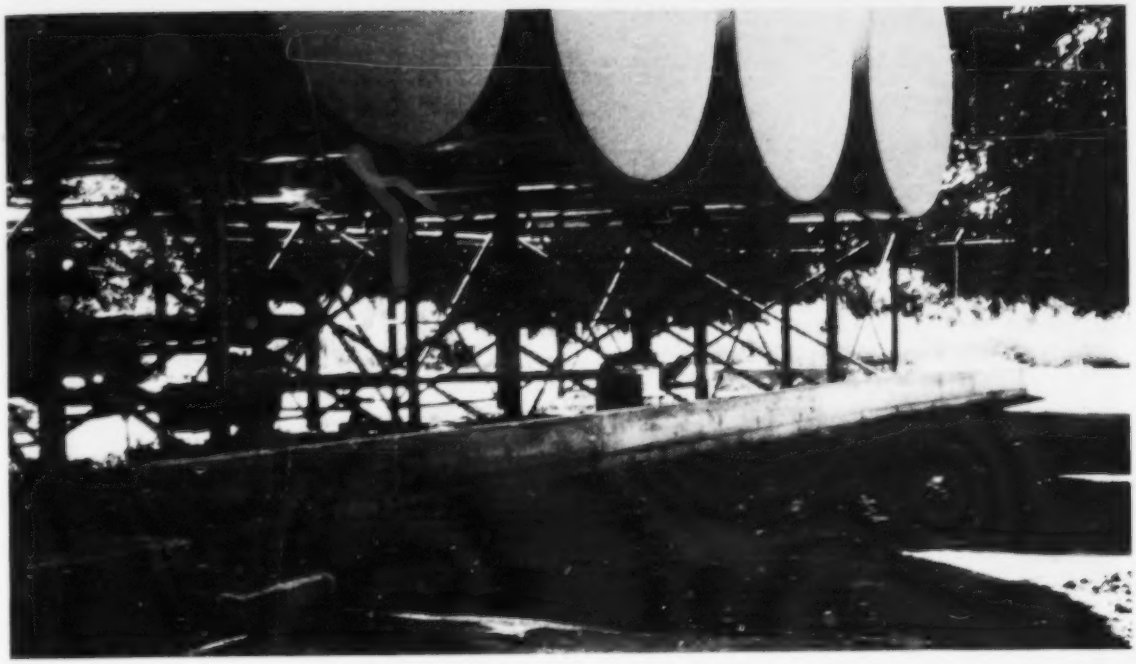
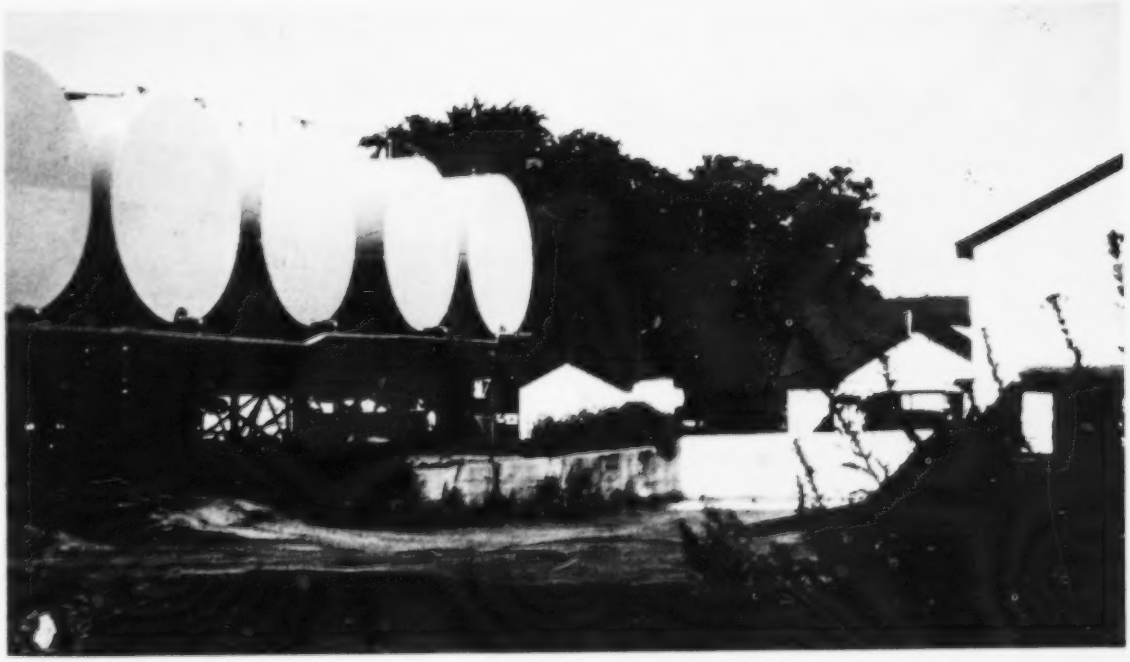
Figure 53 (a & b). Small bulk fuel distributor in Massachusetts, main plant.

The main plant (shown in Figure 53) is completely fenced and the housekeeping and lighting are excellent. The seven 10,000-gallon storage tanks are on high ground in the rear of the facility. The containment volume was obtained by constructing a crosswalk between the building and telephone pole (top photo of Figure 53). The wall on the opposite side of the tank battery has been constructed in such a manner as to divert a spill into the containment area. The concrete loading pad with the catch basin also drains to the containment area.

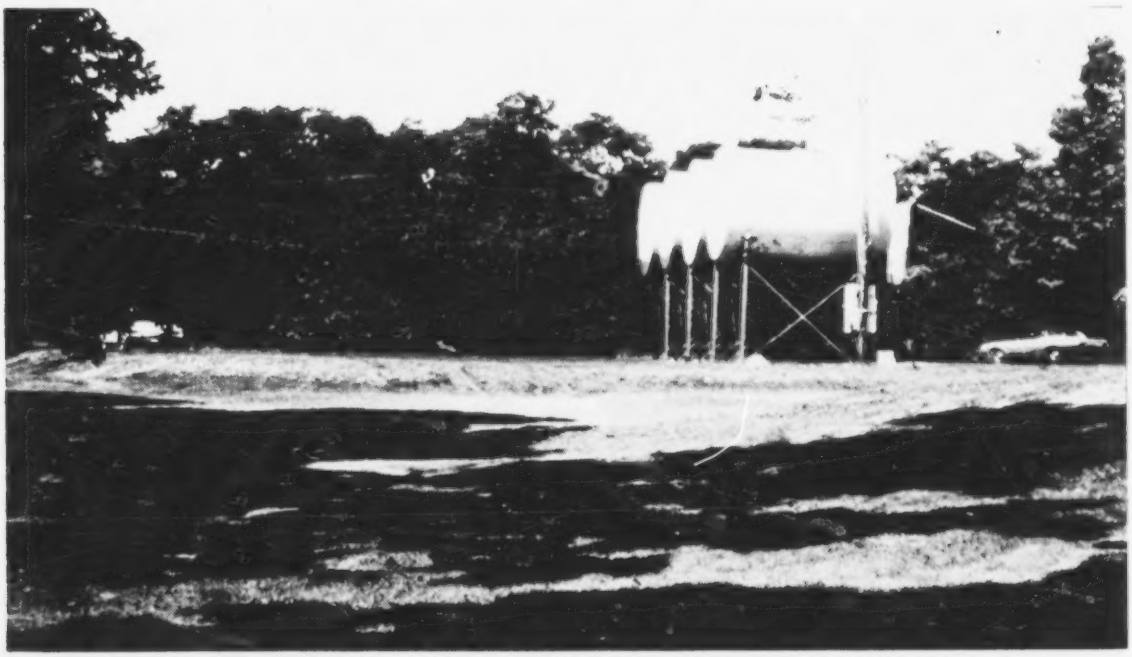
Figure 55. Small bulk fuel distributor in Massachusetts which uses natural topographical features (depression in ground) to catch a potential spill from storage tanks.

Figure 55 shows a 40,000-gallon facility which has had only a small curb installed beyond the tanks and in front of the highway. This curb turns all of the spilled material into a natural grass-lined depression capable of containing the contents of the largest tank.
